**THE CALIFORNIA DEPARTMENT OF FOOD AND AGRICULTURE
HYDRILLA ERADICATION PROGRAM
ANNUAL PROGRESS REPORT 2013**

PROTECTING CALIFORNIA'S WATERWAYS

Prepared by David Kratville, Senior Environmental Scientist,
with the assistance of Program Staff

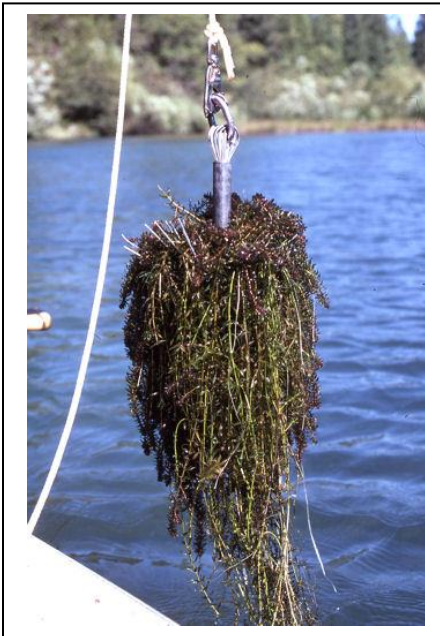
Plate 1. The “hydrilla hook”, a small grappling hook, with hydrilla

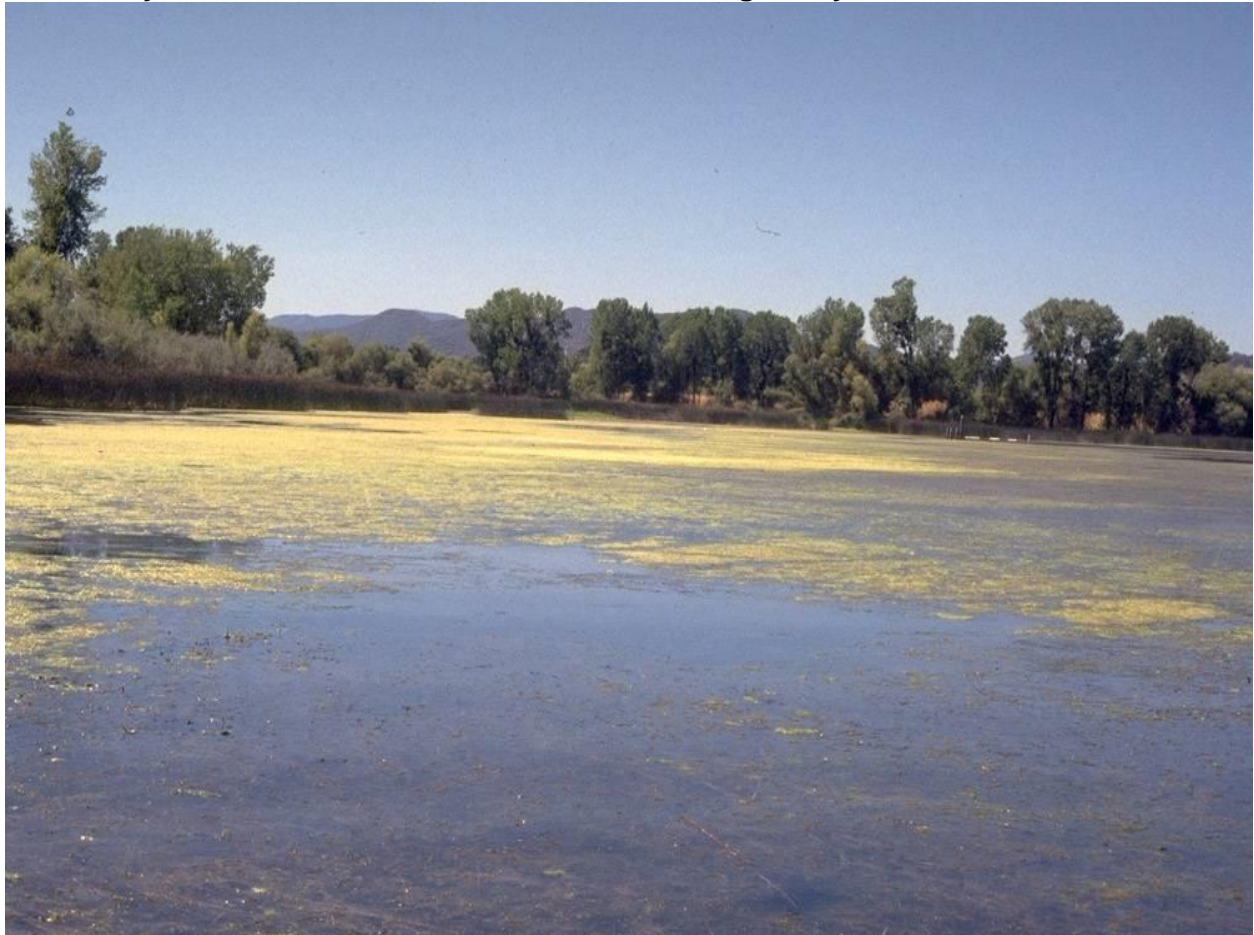
Plate 3: Hydrilla in Clear Lake, 1994, in the area of Big Valley, before treatments started.
